PA46 Operational & Maintenance Information, Nose Gear Steering

Some Piper customers have expressed concerns about the nose gear steering on the PA46 "Malibu" series of aircraft models. This document explains Piper's response to those concerns and provides specific actions that owners can take to ensure that their aircraft continues to operate properly and conform to factory specifications.

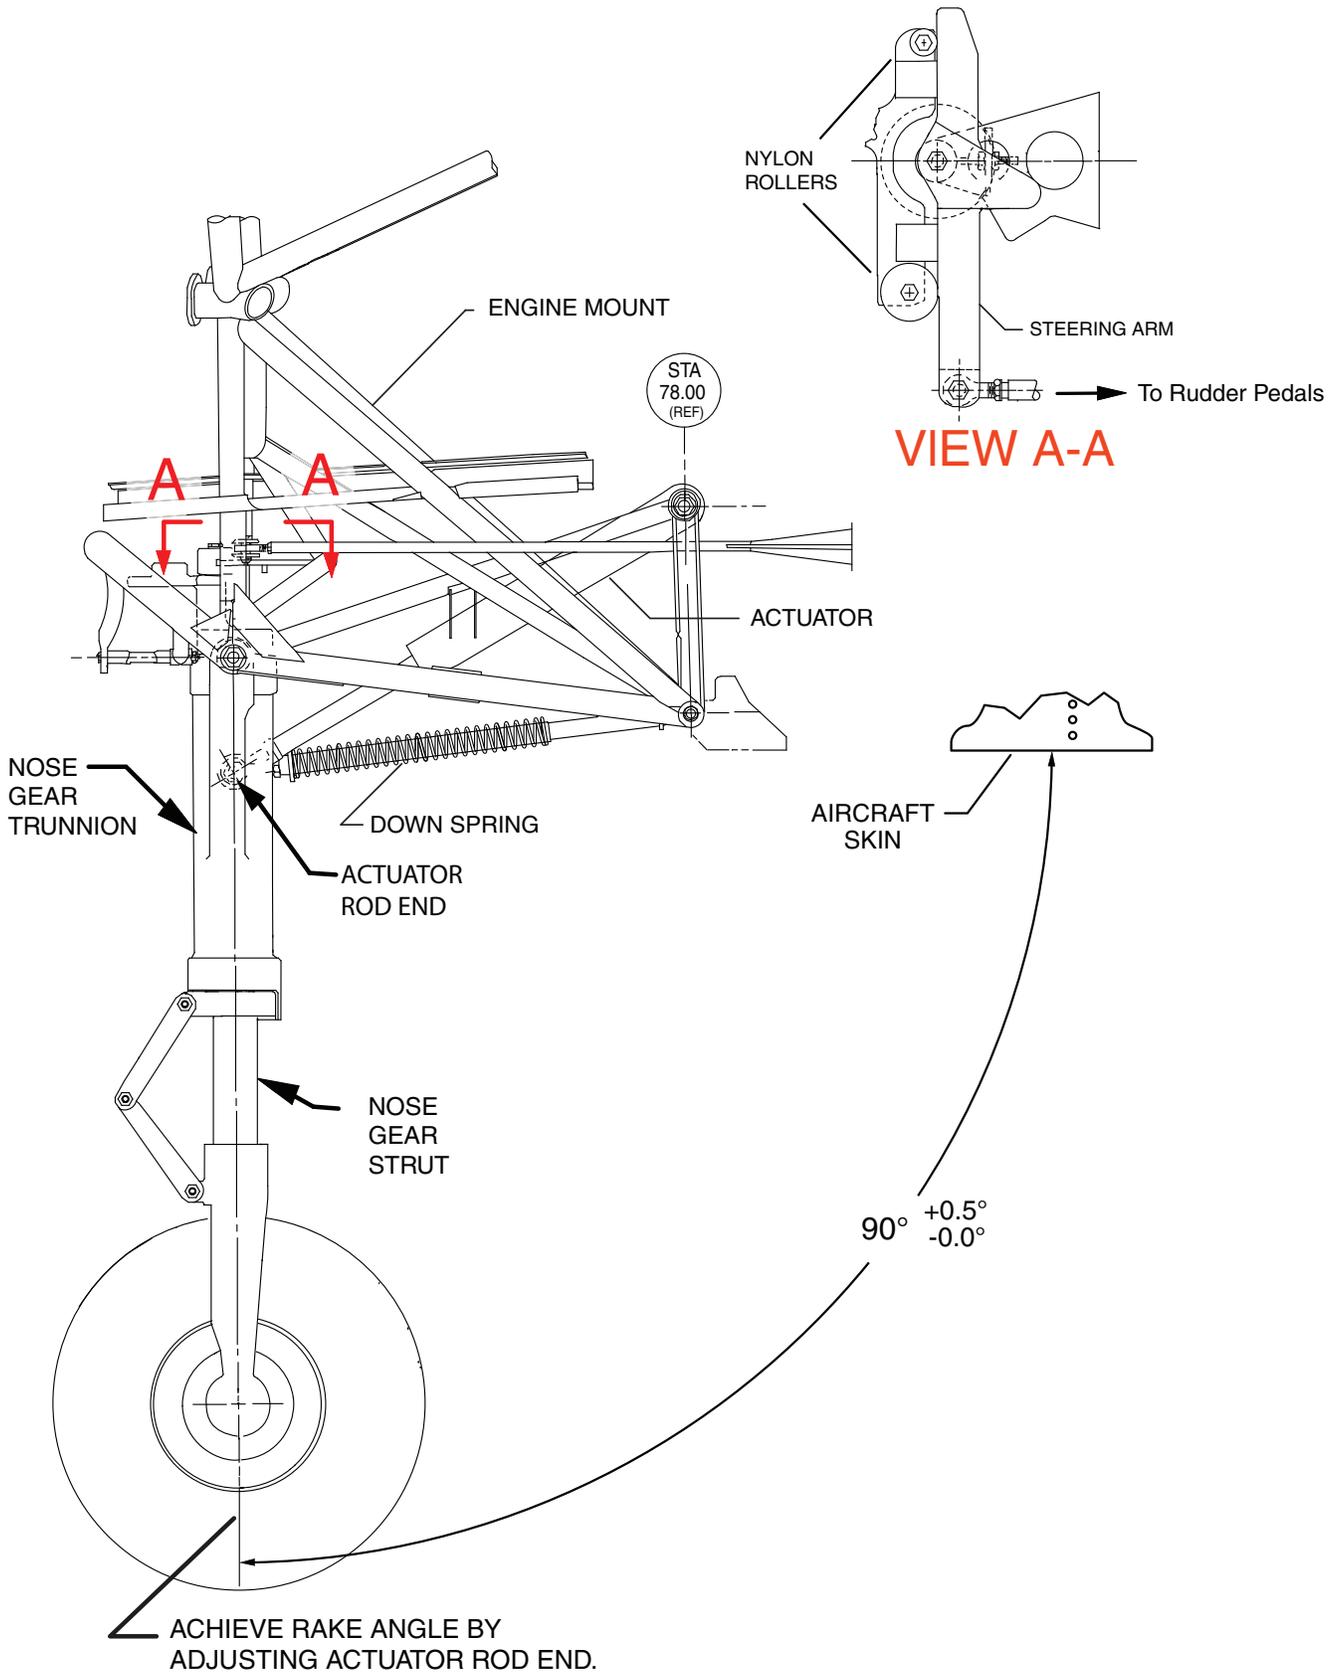
Figure 1

The proper nose gear rake angle for all Malibu models is zero to one-half degree forward from vertical, measured using the airframe lower skin just aft of the nose gear doors as a horizontal datum with the aircraft on jacks. In other words, the relative angle between the lower (belly) skin and the nose gear strut should range from 90.0 degrees to 90.5 degrees. See figure 1.

A rake angle outside of this range may result in dynamic instability, creating steering forces that exceed the pilot’s ability to control. This angle is set by adjusting thread engagement in the nose gear actuator’s rod end bearing as described in the maintenance manual.

The nose gear rake angle is properly adjusted and verified at the factory and should be inspected and/or adjusted by an FAA-licensed mechanic according to the schedule and instructions in the maintenance manual, any time the pilot experiences poor steering, or there is replacement or service to the nose gear trunnion, the nose gear actuator, or the engine mount.
