**Piper Aircraft, Inc.**  
2926 Piper Drive  
Vero Beach, Florida, U.S.A. 32960

# SERVICE No. 1035A BULLETIN

**Distribution of Textron Lycoming Service Bulletin 529B, "Reprint of Crane/Lear/Romec Service Bulletin No. 101SB020, Rev. 3"**

## FUEL PUMP – Torquing of Relief Valve Cover Screws.

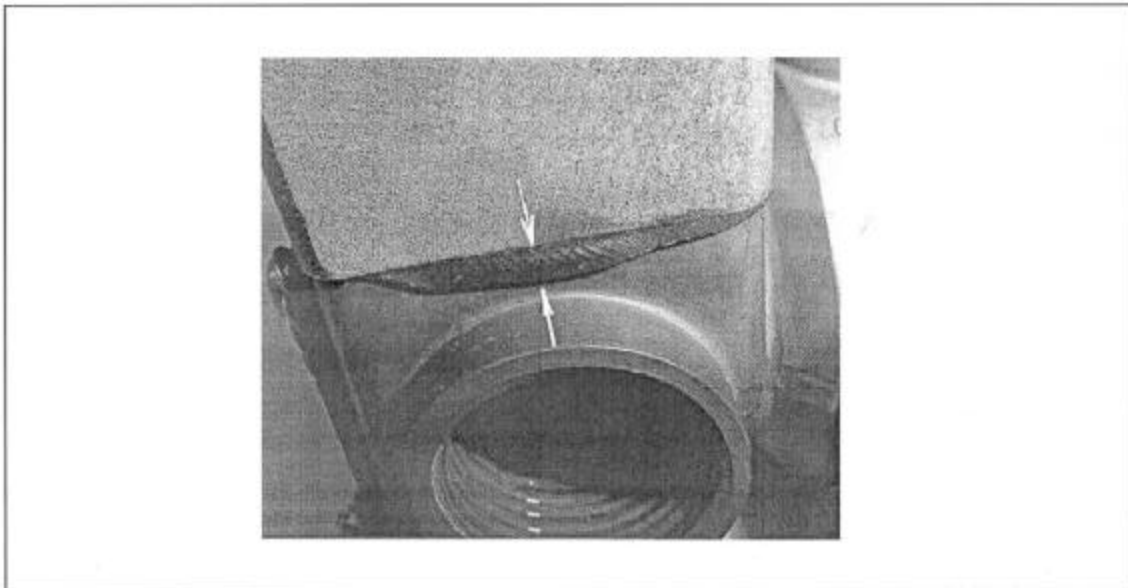
Excessive Extrusion – All Series  
Figure 4

There have been field reports of fuel leakage past the relief valve gasket on several of the above listed fuel pumps. This condition could result in a fire hazard, fuel flow fluctuation, or engine stoppage.

- (a) Visually inspect the split lines between the pump housing, relief valve housing and relief valve cover for evidence of fuel leakage or noticeable gasket extrusion adjacent to the pump inlet and outlet ports. If there is evidence of fuel leakage or noticeable extrusion, replace the pump per applicable engine maintenance instructions. (See figures 1,2,3 & 4.)
- (b) Check the tightness of relief valve cover attaching screws using a torque indicating screwdriver. Minimum torque shall be 23 inch-pounds. Torque shall be checked in the tightening direction.
