The New Piper Aircraft, Inc.  
 2926 Piper Drive  
 Vero Beach, Florida, U.S.A. 32960

# SERVICE No. 1103B BULLETIN

Date: November 25, 2003 (S)

<b><u>SUBJECT:</u></b>	<b>ENGINE MOUNT INSPECTION</b>
<b><u>MODELS AFFECTED:</u></b>	<b><u>SERIAL NUMBERS AFFECTED:</u></b>
PA-46-310P Malibu	46-8408001 through 46-8408087, 46-8508001 through 46-8508109, 46-8608001 through 46-8608067, and 4608001 through 4608140
PA-46-350P Mirage	4622003 through 4622200 4636001 through 4636319
PA-46-500TP Meridian	4697001 through 4697071; 4697075 through 4697096; 4697100; 4697101; 4697103 through 4697112; 4697114 and 4697116

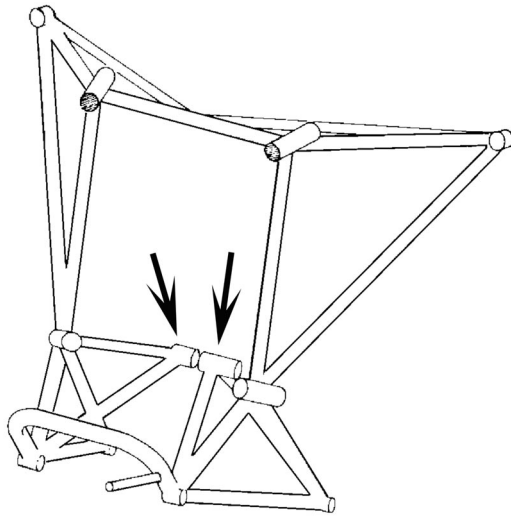
**(PA-46-310/350P)**  
**Typical Engine Mount**  
**(Arrows indicate Engine Mount Actuator Attach Feet)**  
**Figure 1A**

**PURPOSE:** It has been determined that cracks may develop on the engine mount in the area of the nose gear actuator attach feet (see Figure 1A). This condition typically occurs when the nose landing gear is subjected to excessive loads, possibly through hard landings, rough field operations, excessive speed turns and/or improper towing of the aircraft.

3. Visually inspect the engine mount actuator attach feet for cracks.
4. Perform a 'liquid penetrant inspection' of the engine mount actuator attach feet for cracks per AC 43.13-1B, Chapter 5, Section 5.

1. Clean the engine mount actuator attach feet area.
2. Remove the paint or Dinitrol AV8, if the paint was previously removed and covered with Dinitrol AV8, from the feet (ref. Figure 1A).

5. If a crack appears in either of the actuator attach feet, the engine mount must be replaced before further flight. The installation of the appropriate engine mounts (see Table 1 on Page 2), with the one (1) piece feet (see Figure 3) constitute compliance with PART I and PART II of this Service Bulletin.

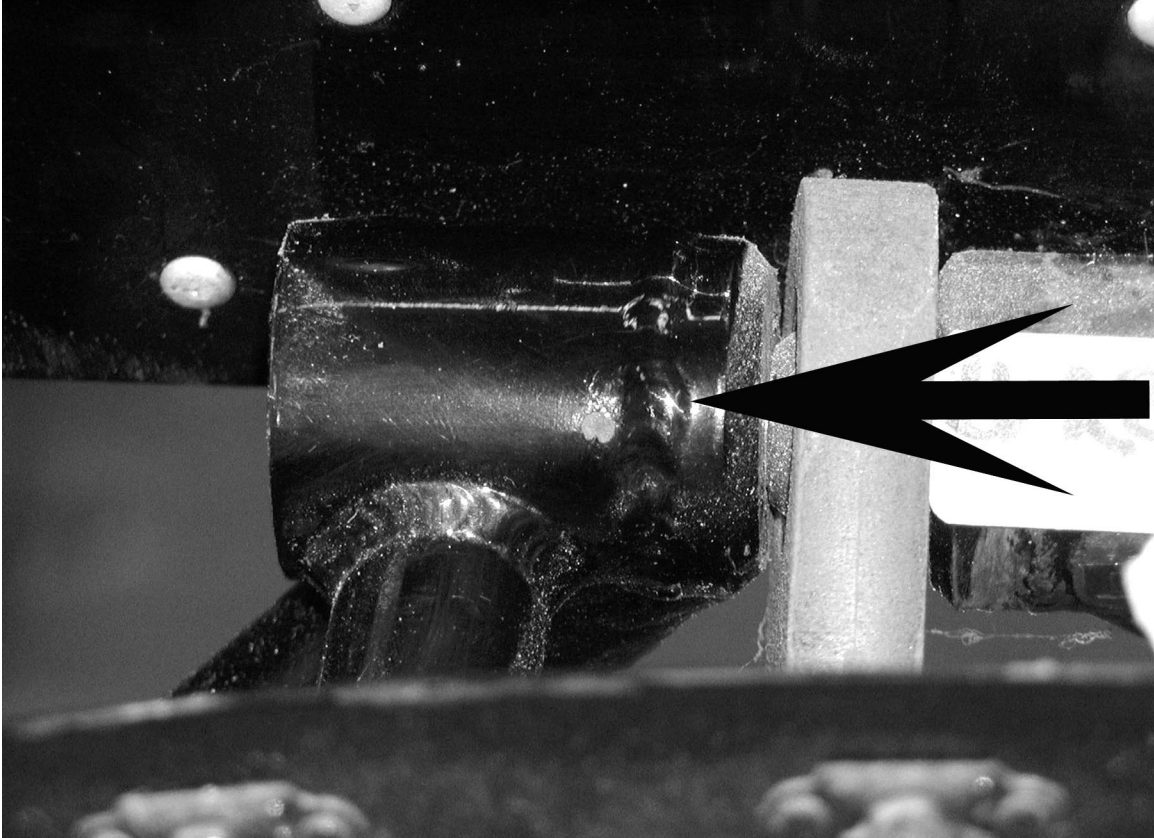
1. If cracks are found on the engine mount, replace with the engine mount listed in Table 1 for the applicable aircraft type. Insure the new engine mount has the one (1) piece feet (see Figure 3). The old engine mount (see Figure 2) has a two (2) piece welded foot. This welded area is where the crack's in the engine mounts have been found. Replace engine mount per the Aircraft Maintenance Manual, Chapter 71-00-00.

Figure 2  
Old Engine Mount  
Weld Indicates Two (2) Piece Foot

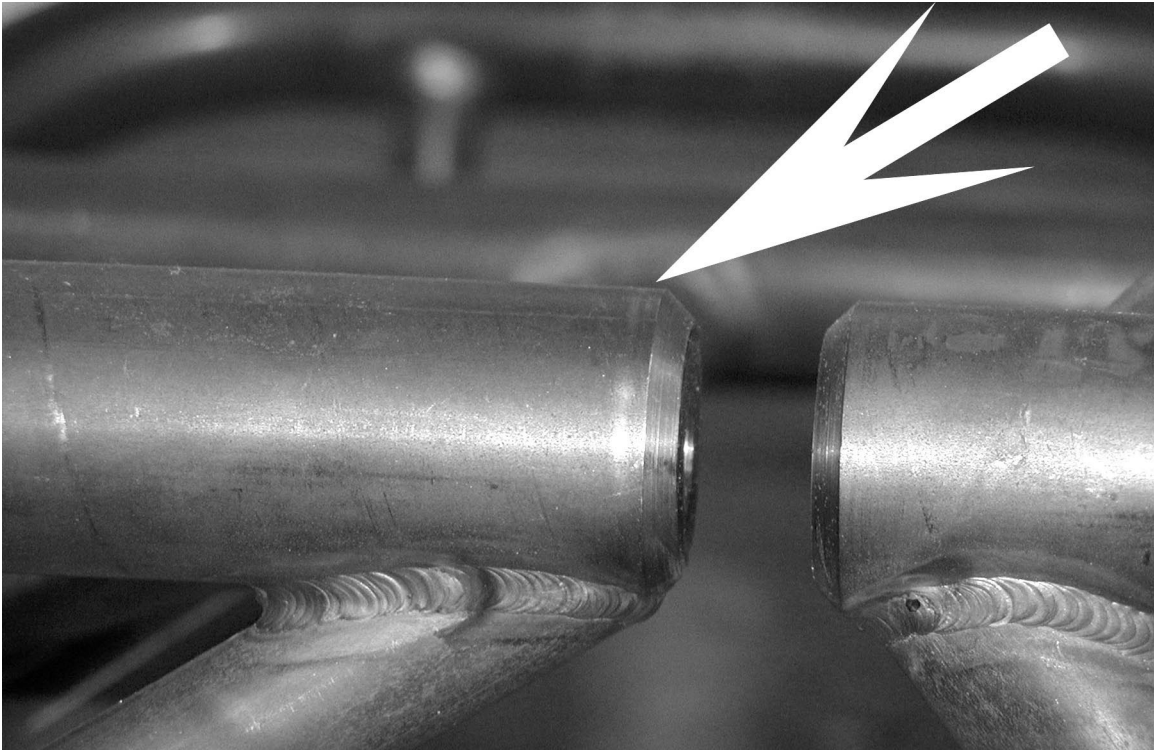
Figure 3  
New Engine Mount  
No Weld - One (1) Piece Foot
