Piper Aircraft, Inc.
 2926 Piper Drive
 Vero Beach, Florida, U.S.A. 32960

SERVICE No. 1154B BULLETIN

Date: March 28, 2007 (S)

<u>SUBJECT:</u>	ENGINE MOUNT INSPECTION
<u>MODELS AFFECTED:</u>	<u>SERIAL NUMBERS AFFECTED:</u>
PA-46-500TP Meridian	4697001 through 4697240 and 4697242 through 4697244

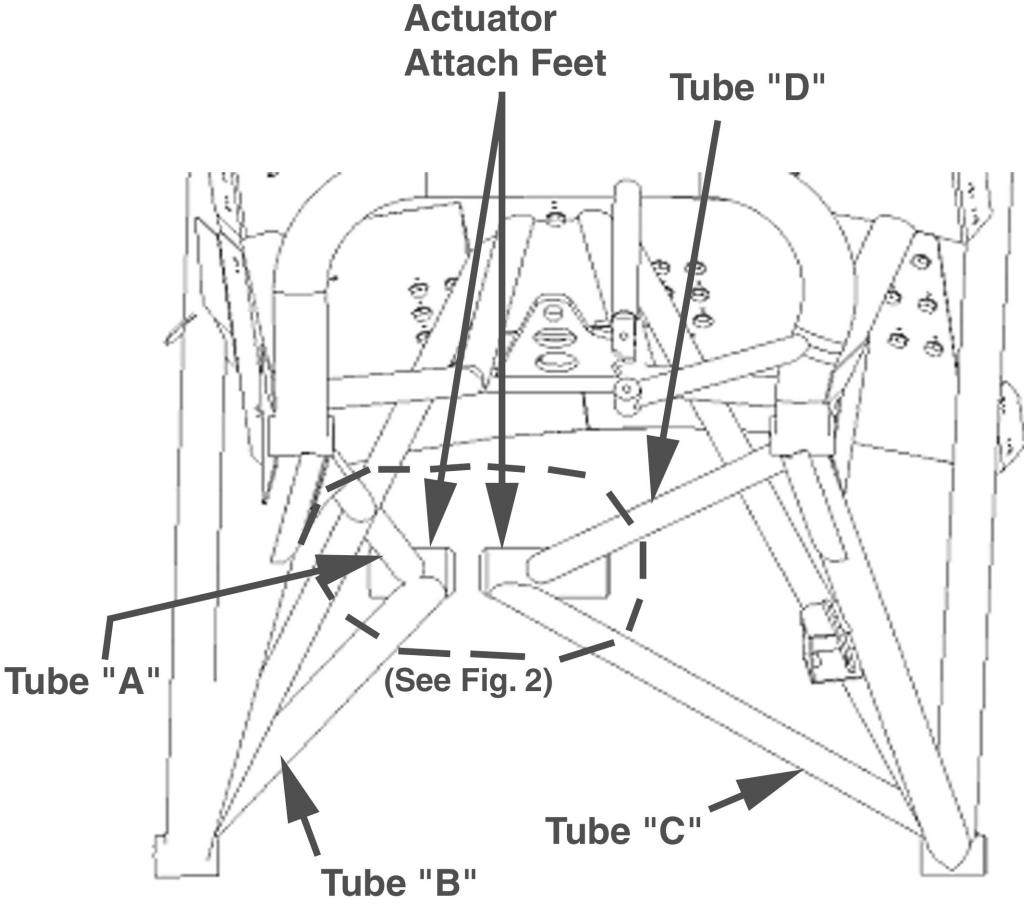
NOTE: This service bulletin is similar to SB1103B except this bulletin requires inspection of the adjacent tubes "A" thru "D" (Fig. 1 and 2) in addition to the attach feet. This bulletin also requires inspection of tubes shown in Fig. 3 and 4 at the left and right side nose gear pivot areas.

PURPOSE: It has been determined that cracks may develop on the engine mount in the area of the nose gear actuator attach feet (see Figure 1 and 2) and in the areas immediately outboard of the nose gear pivot points. The likelihood of this condition occurring increases when the nose landing gear is subjected to repetitive excessive loads, possibly through hard landings, rough field operations, repetitive excessive speed turns and/or improper towing of the aircraft.

1. Remove the nose gear hydraulic actuator and the nose gear assembly from the engine mount per the Aircraft Maintenance Manual, Chapter 32-20-00. Clean the engine mount actuator attach feet area including tube welds as shown in Fig. 1 and 2. Clean the inboard sides of the mount within 2 inches of the nose gear attach points as shown in Fig. 3 and Fig. 4.

5. Inspect the entire length of each weld on the attach feet. A mirror will be required to inspect the upper surface of the attach feet and associated tubes. If a crack appears, the engine mount must be replaced before further flight as outlined in Part II (see below).
