Piper Aircraft, Inc.
2926 Piper Drive
Vero Beach, Florida, U.S.A. 32960

SERVICE No. 1175 BULLETIN

PILOT'S SIDE WINDOW INSPECTION

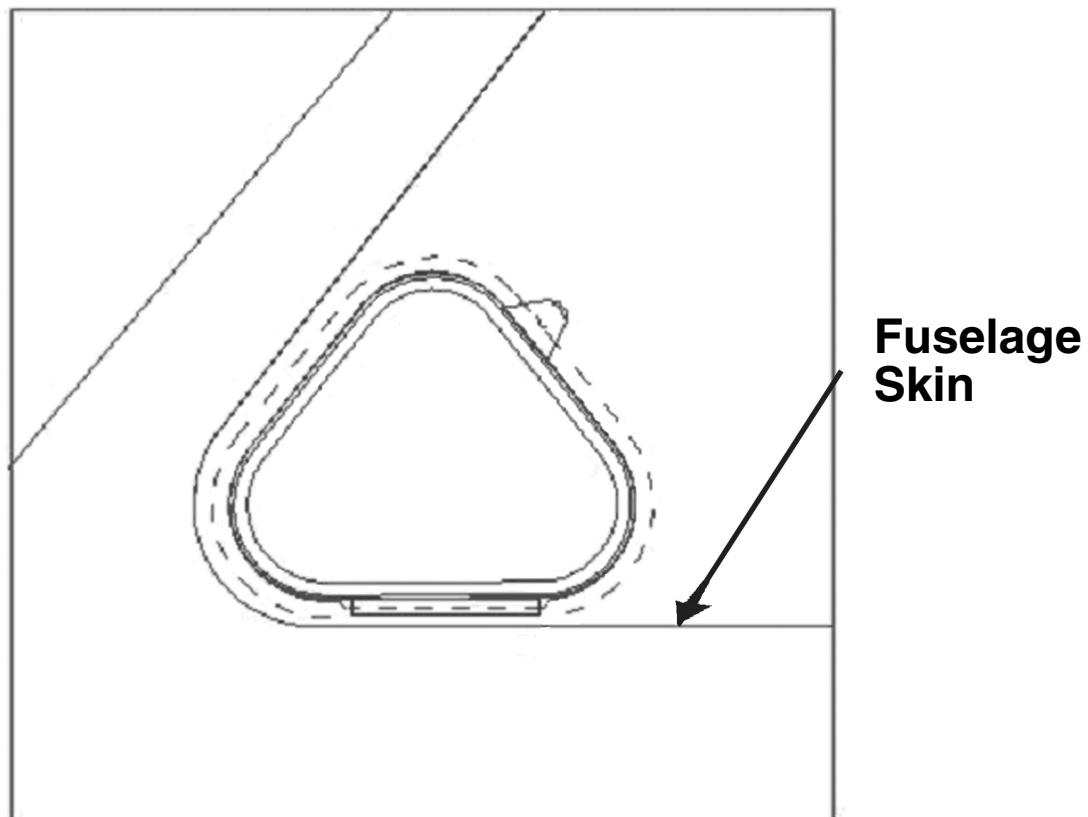
Figure 1
Left Side Looking Inboard

Piper has received reports from the field that a crack may develop in the pilot's side window, adjacent to the lower aft corner of the storm window. The purpose of this Service Bulletin is to provide inspection and replacement instructions.

Refer to Figures 1, 2 and 3 and inspect the window in the area indicated by the circle.

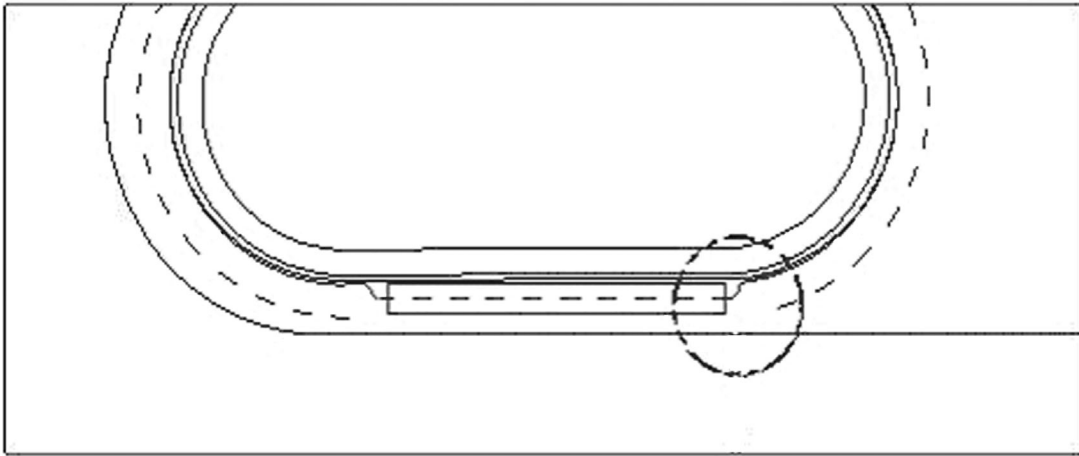
Figure 2
Left Side Looking Inboard
Inspection Area

NOTE: If a crack exists in the area identified by the circle in Figure 2 or 3, continued operation of the aircraft is allowed, provided that the cabin remains un-pressurized at all times.

1. If a crack is found in the window of the PA-46-310P or a PA-46-350P, serial numbers 4622001 through 4636076, install the Piper Service Kit 88342-002, Piper Code No. 767-355. For PA-46-350P serial numbers 4636077 and up and all PA-46-500TP aircraft, replace the window per the appropriate Aircraft Maintenance Manual, Chapter 56-10-00. Repetitive inspections will continue to be required after the Service Kit is installed and/or the window is replaced. Replacement of the window will allow the aircraft to operate with the cabin pressurized according to the P.O.H, Sections 2 and 4. Piper Aircraft, Inc. is currently developing an improved design that will eliminate the need for repetitive inspections.
2. Make an appropriate logbook entry indicating compliance of **PART II** with this Service Bulletin.
