Piper Aircraft, Inc.
2926 Piper Drive
Vero Beach, Florida, U.S.A. 32960

SERVICE No. 1175A BULLETIN

PILOT'S SIDE WINDOW INSPECTION

PA-46-310P Malibu

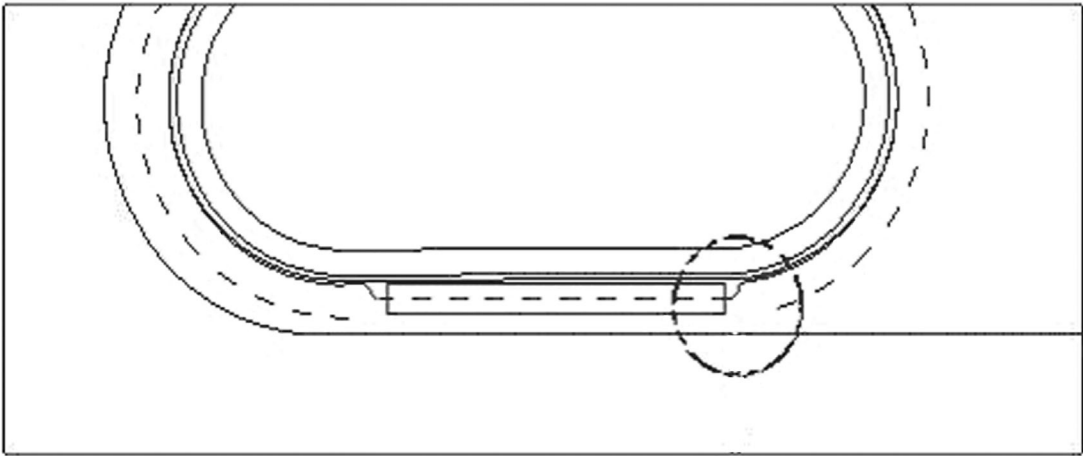
Figure 2
Left Side Looking Inboard
Inspection Area

Piper has received reports from the field that a crack may develop in the pilot's side window, adjacent to the lower aft corner of the storm window. The purpose of this Service Bulletin is to provide inspection and replacement instructions.

Refer to Figures 2 and 3 and inspect the window in the area indicated by the circle.

NOTE: If a crack exists in the area identified by the circle in Figure 2 or 3, continued operation of the aircraft is allowed, provided that the cabin remains un-pressurized at all times.

1. If sealant exists between the storm window hinge and the airframe skin, remove the sealant very carefully with a plastic scraper, ensuring that the window is not scratched. It is not necessary to replace the sealant after inspection. Remove the sealant from the area between the hinge and skin only. If no crack is found, continue to inspect the window at 50 hour intervals until the window is replaced with the new window without a storm window, which relieves the requirement for repetitive inspection. If a crack exists follow instructions in **Part II**.
