2017 Accident & Safety Review

by Manny Casiano

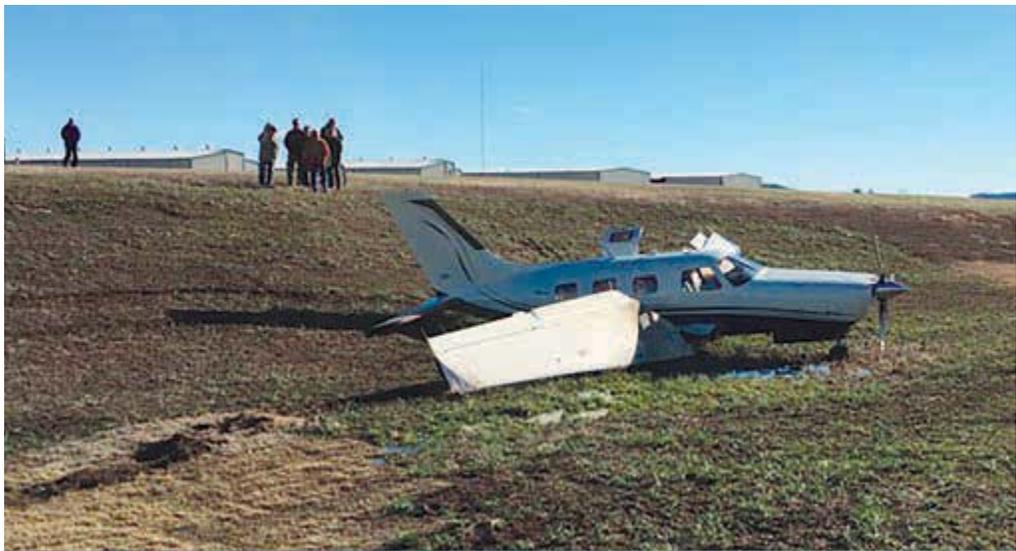
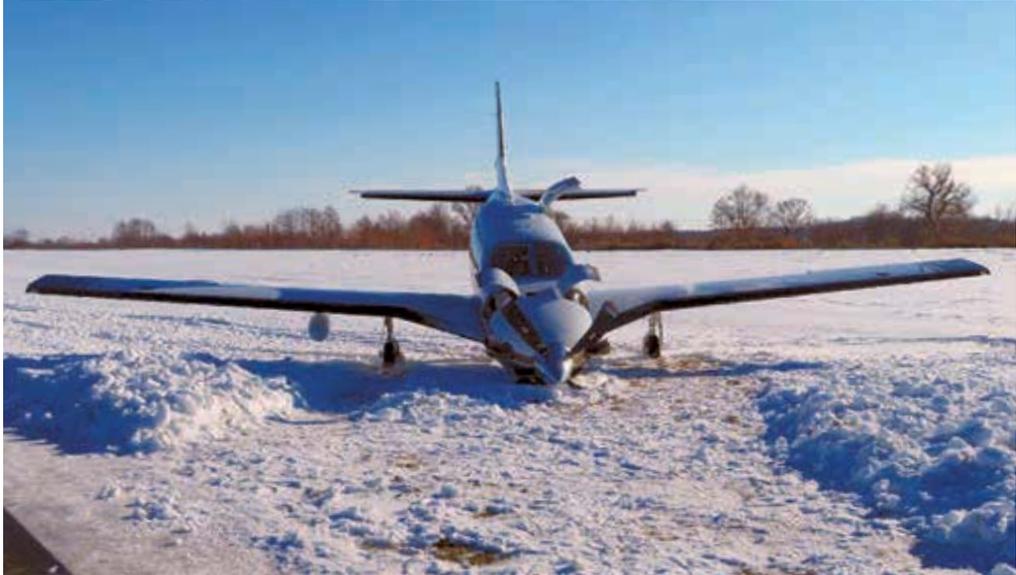
Next is another landing accident. (Are you starting to see a pattern?) This was a Mirage with an experienced pilot. The landing runway in Nashville had a direct right crosswind at 15-17 kts. The pilot didn't like his first approach, and (wisely) went around. On his second approach, he landed on the centerline, but then veered left and

the pilot tried to abort the landing with power. The plane ended up in a ditch off the runway, with significant damage to the wings, but with no injuries. I don't know yet if there were any mechanical factors contributing to the loss of control.

My takeaways from this accident are to practice and be cautious with strong and/or gusty crosswinds. I personally don't use full flaps with strong crosswinds, but that's personal preference. Finally, once you're on the runway, and losing directional control, do **NOT** try to take off again. There are too many PA46 accidents that have been converted from airframe damage with no injuries (the usual with low speed runway excursions) to fatalities at high speed/low altitude. You are almost always safer staying on the ground

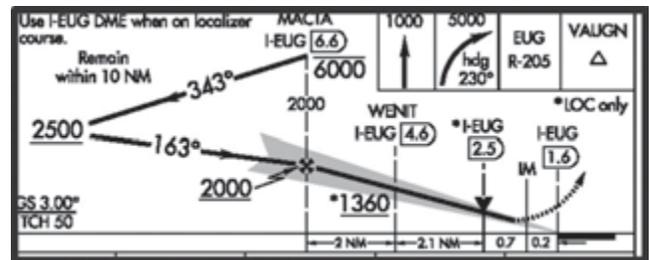
Above is the profile view from the ILS plate.

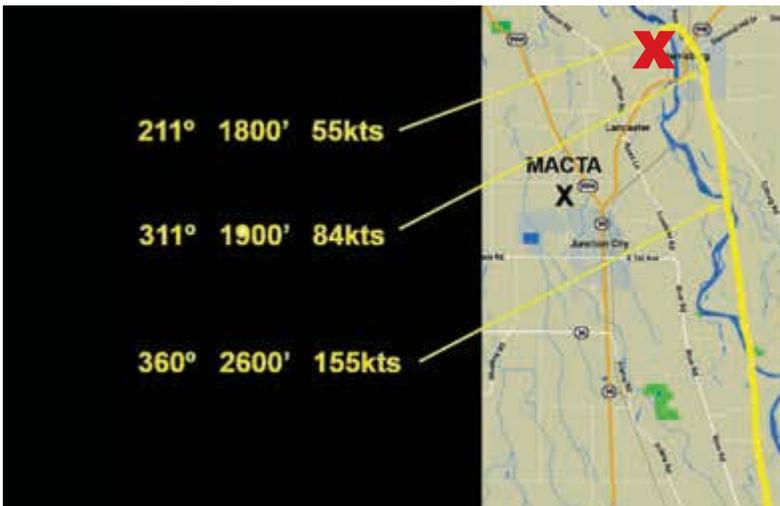
The descent from 2,600 feet makes sense (give or take 200 feet). What doesn't make sense to me is the groundspeed on the descent/level off. Of course, as the pilot turns back into a stiff wind, the groundspeed will drop a lot – but 55 kts groundspeed, at a point still 10 miles from the runway threshold, just seems too slow to me, even accounting for the winds at 1,800 feet.

The wreckage of the plane was found in a field near the red **X**; the four people on board died.

We'll know more when the factual NTSB report is released. But at this point, it looks suspiciously like a stall/spin accident during an approach in turbulent conditions. I am certain the weather paid a large role in this tragic outcome.

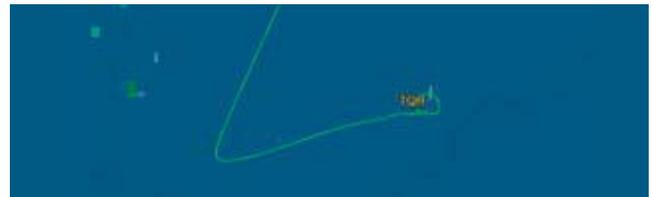
Approximately a third into the trip, the plane lost some, and eventually all, engine power, right around the red **X** (below left).

He turned toward Tahlequah (TQH), which was the closest field; you can see the nice smooth turn and track to that nearest airport on the FlightAware track.
