The New Piper Aircraft, Inc.  
 2926 Piper Drive  
 Vero Beach, Florida, U.S.A. 32960

# SERVICE No. 1103B BULLETIN

Date: November 25, 2003 (S)

<b><u>SUBJECT:</u></b>	<b>ENGINE MOUNT INSPECTION</b>
<b><u>MODELS AFFECTED:</u></b>	<b><u>SERIAL NUMBERS AFFECTED:</u></b>
PA-46-310P Malibu	46-8408001 through 46-8408087, 46-8508001 through 46-8508109, 46-8608001 through 46-8608067, and 4608001 through 4608140
PA-46-350P Mirage	4622003 through 4622200 4636001 through 4636319
PA-46-500TP Meridian	4697001 through 4697071; 4697075 through 4697096; 4697100; 4697101; 4697103 through 4697112; 4697114 and 4697116

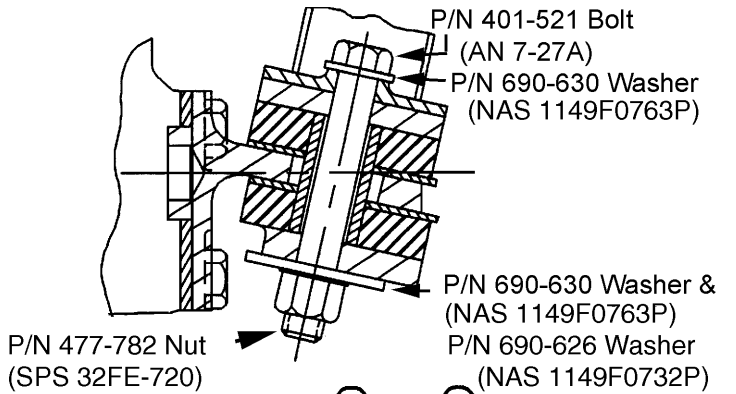
**(PA-46-310/350P)**  
**Typical Engine Mount**  
**(Arrows indicate Engine Mount Actuator Attach Feet)**  
**Figure 1A**

**PURPOSE:** It has been determined that cracks may develop on the engine mount in the area of the nose gear actuator attach feet (see Figure 1A). This condition typically occurs when the nose landing gear is subjected to excessive loads, possibly through hard landings, rough field operations, excessive speed turns and/or improper towing of the aircraft.

3. Visually inspect the engine mount actuator attach feet for cracks.
4. Perform a 'liquid penetrant inspection' of the engine mount actuator attach feet for cracks per AC 43.13-1B, Chapter 5, Section 5.

5. If a crack appears in either of the actuator attach feet, the engine mount must be replaced before further flight. The installation of the appropriate engine mounts (see Table 1 on Page 2), with the one (1) piece feet (see Figure 3) constitute compliance with PART I and PART II of this Service Bulletin.

1. If cracks are found on the engine mount, replace with the engine mount listed in Table 1 for the applicable aircraft type. Insure the new engine mount has the one (1) piece feet (see Figure 3). The old engine mount (see Figure 2) has a two (2) piece welded foot. This welded area is where the crack's in the engine mounts have been found. Replace engine mount per the Aircraft Maintenance Manual, Chapter 71-00-00.
