2017 Accident & Safety Review

by Manny Casiano

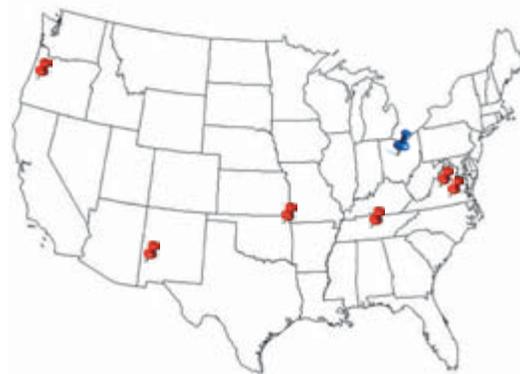
This figure shows the geographic distribution of accidents for last year:

The blue pushpin is an accident that doesn't appear in the NTSB database, and there is also an accident in Germany that the NTSB doesn't record.

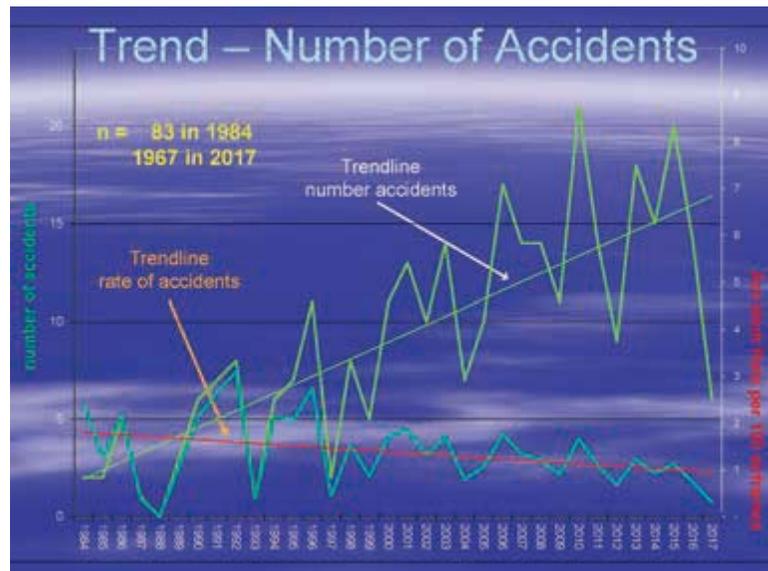
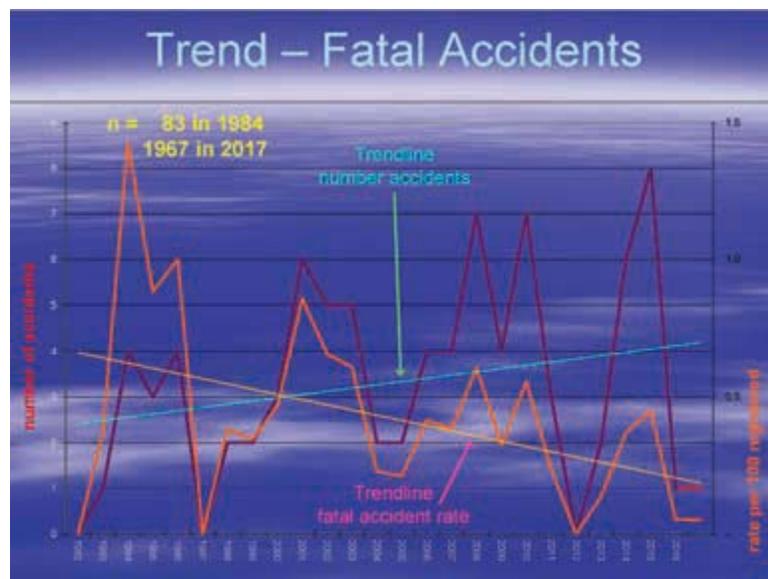
Here (right) is the same type of chart, but just for fatal accidents.

You can see we've had three of the past 25 years with zero fatal accidents, and 2016 and 2017 with only one fatal
